ASBESTOS AND LEAD-CONTAINING MATERIALS DEMOLITION SURVEY REPORT

**SAN MIGUEL FIRE DISTRICT
CREST STATION 18 AND FIRE STATION VEHICLE GARAGE
1811 SUNCREST BOULEVARD,
EL CAJON, CALIFORNIA 92021**

PROJECT NO. 119480 - AS, XRF, LS

**SURVEY DATE: FEBRUARY 6, 2024
REPORT DATE: FEBRUARY 20, 2024**

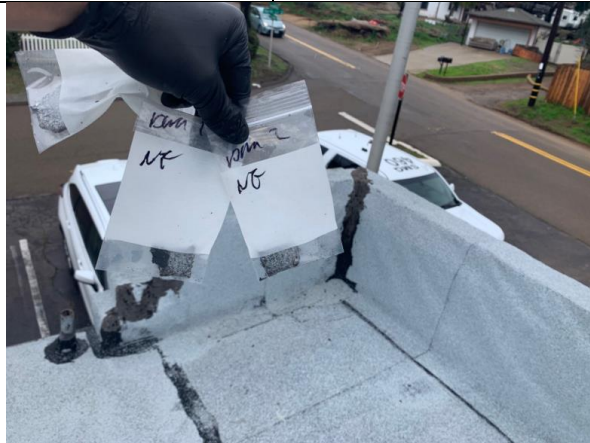
Photo of HA number 2, Sample No. 0206-02-05
0206-02-06 | Non-ACM Gray Parapet Wall, within Station 18 Roof

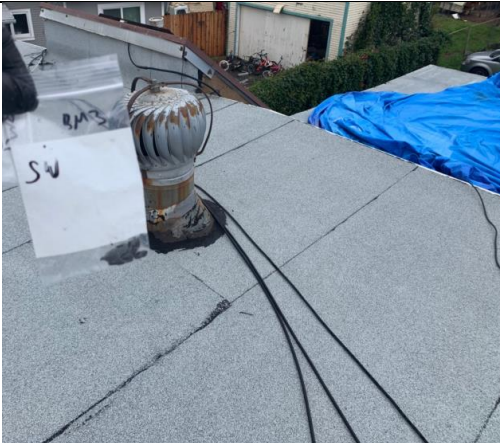
Photo of HA number 3, Sample No. 0206-03-09 |
Non-ACM Black Roof Mastic, within Crest Station 18
Roof

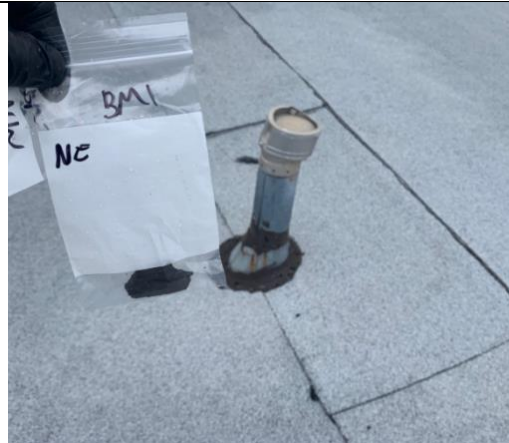
Photo of HA number 4, | Non-ACM Sample No. 0206-04-
11 Black Roof Seam Mastic, Within Crest Station 18 Roof

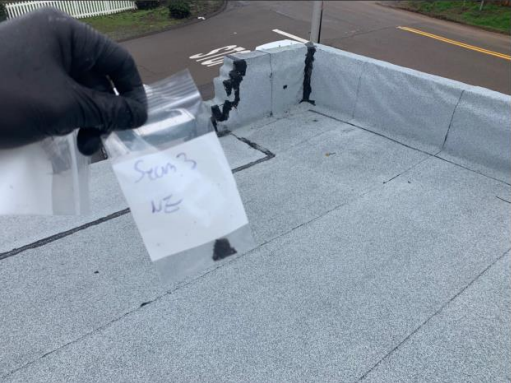
Photo of HA number 7, Sample No. 0206-07-21 | **ACM** Black Metal Seam Mastic, within Crest Station 18 Roof

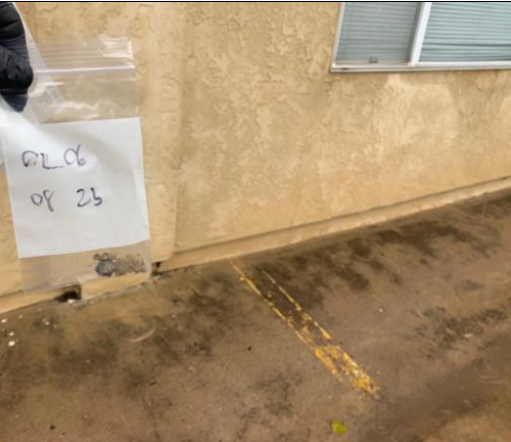
Photo of HA number 8, Sample No. 0206-08-23 | Non-ACM Tan Exterior Stucco, Within Exterior Station 18

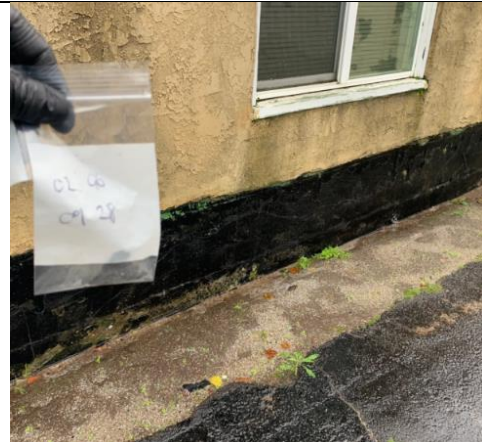
Photo of HA number 9, Sample No. 0206-09-28 | Non-ACM Black Exterior Vapor Barrier, within Exterior Station 18

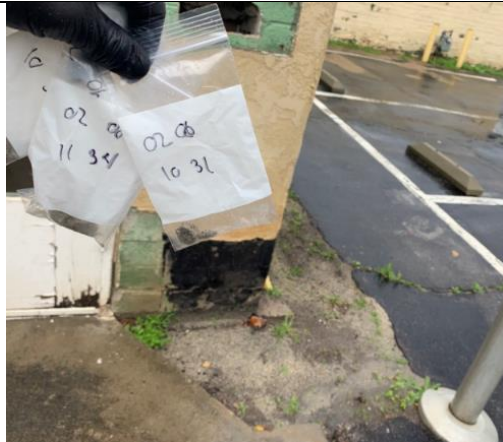
Photo of HA number 10 & 11, Sample No. 0206-10-31 & 0206-11-34 | Non-ACM Gray Block Wall & Gray Block Wall Mortar, within Exterior Station 18

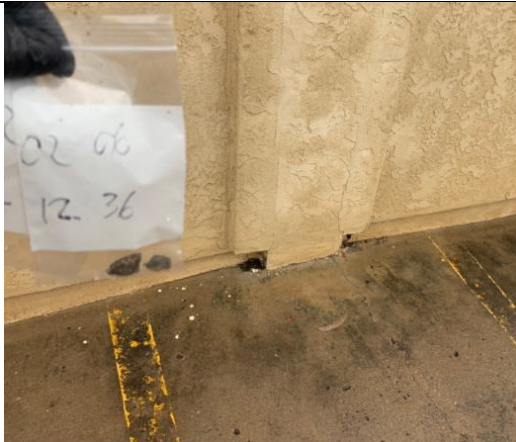
Photo of HA number 12, Sample No. 0206-12-36 | Non-ACM Gray Concrete Pad, Within Exterior Station 18

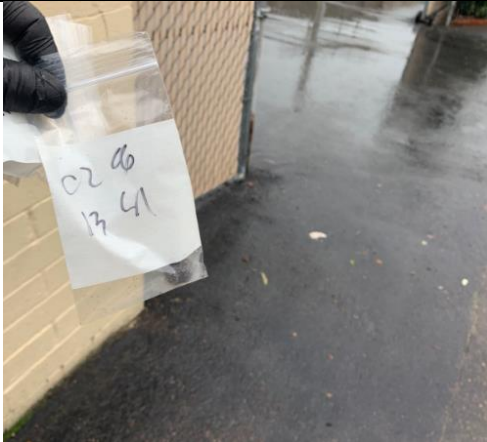
Photo of HA number 13, Sample No. 0206-13-41 | Non-ACM Black Asphalt, Within Parking Lot Station 18

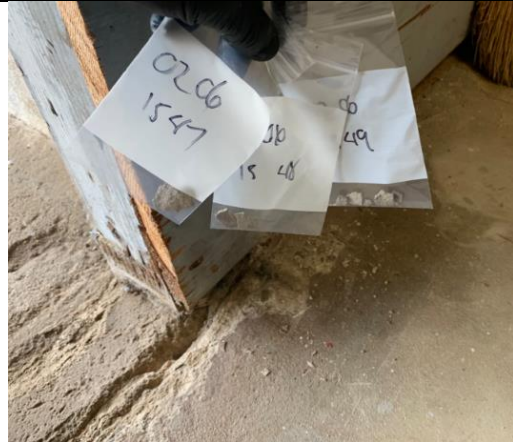
Photo of HA number 15, Sample No. 0206-15-47, 0206-15-48 & 0206-15-49 | Non-ACM Gray Concrete Slab, Within Slab Fire Station 18

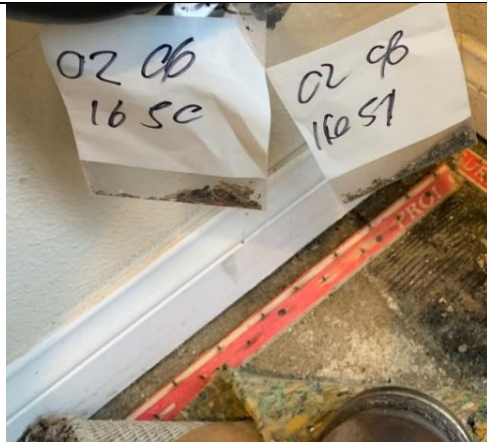
Photo of HA number 16, Sample No. 0206-16-50 & 0206-16-51 Orange and Black Carpet Mastic, Within Front Office and Captains Office

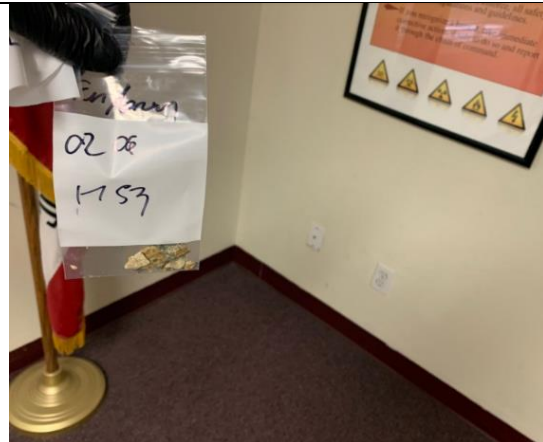
Photo of HA number 17, Sample No. 0206-17-53 | Non-ACM Orange and Green Carpet Mastic, Within Day Room

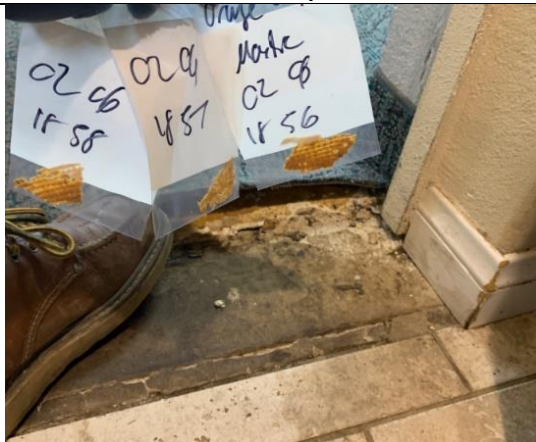
Photo of HA number 18, Sample No. 0206-18-56, 0206-18-57 & 0206-18-58 | Non-ACM Orange Carpet Mastic, within Open Room

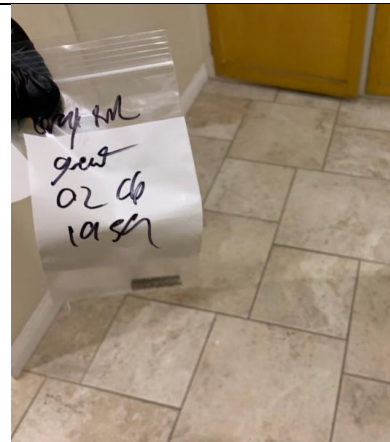
Photo of HA number 19, Sample No. 0206-19-59 | Non-ACM Gray Tile Grout, Within Hallway and Kitchen

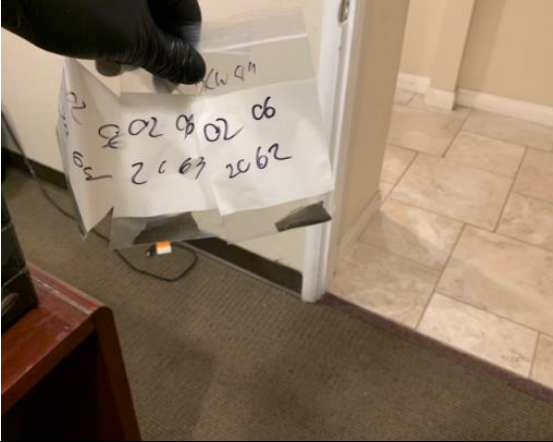
Photo of HA number 20, Sample No. 0206-20-62, 0206-20-63 & 0206-20-64 | Non-ACM Brown 4" Cove Base, within Captains Office

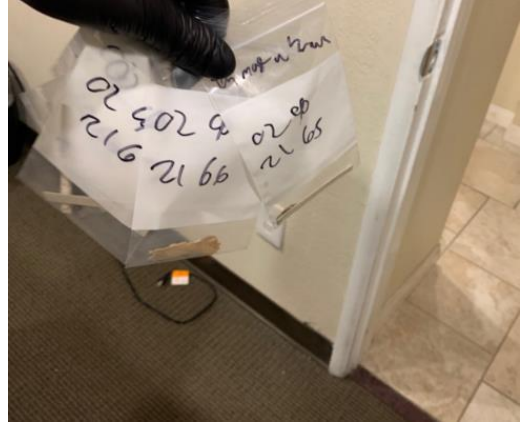
Photo of HA number 21, Sample No. 0206-21-65, 0206-21-66 & 0206-21-67 | Non-ACM White 4" Cove Base Mastic Associated with Beam, within Captains Office

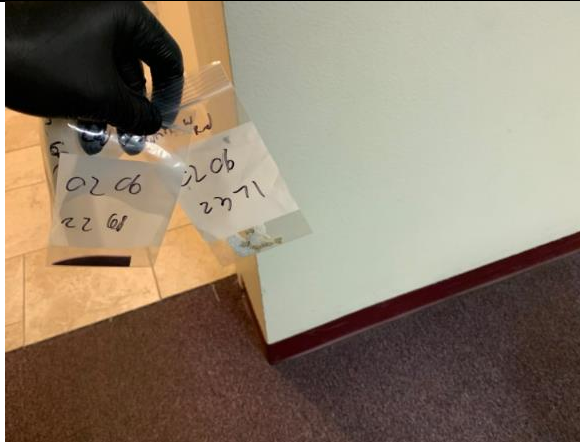
Photo of HA number 22 & 23, Sample No. 0130-17-51 | Non-ACM Red 4" Cove Base and White / Red 4" Cove Base Associated with Mastic, Within Open Room, Day Room and Bedroom 1

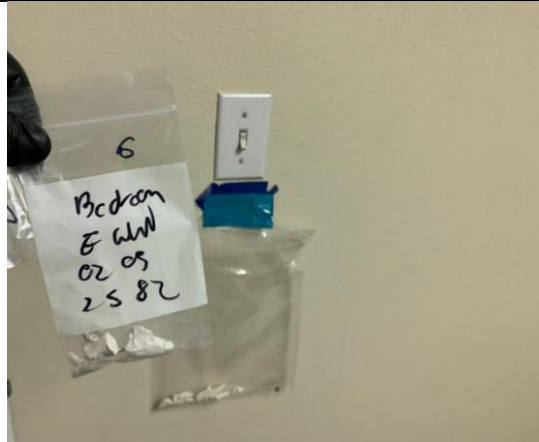
Photo of HA number 25, Sample No. 0206-25-82 | Non-ACM White Drywall and Joint Compound, Within Front Office, Captains Office, Hallway, Day Room, Bathroom 2, Bedroom 1 and Open Room

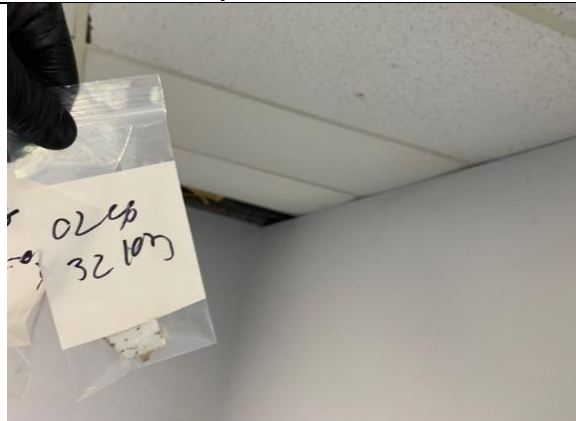
Photo of HA number 32, Sample No. 0206-32-103 | Non-ACM White 2'x4' Ceiling Tile, within Open Room

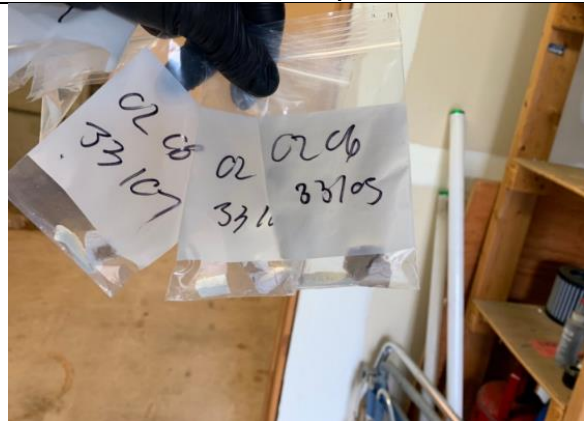
Photo of HA number 33, Sample No. 0206-33-105, 0206-33-106 & 0206-33-107 | Non-ACM White Drywall / Joint Compound (Unfinished), within Storage Room 1

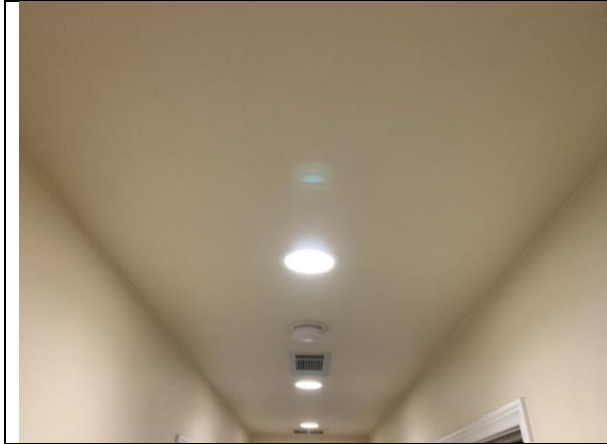
Photo of sample number 15, BDL Drywall Ceiling, Within Hallway

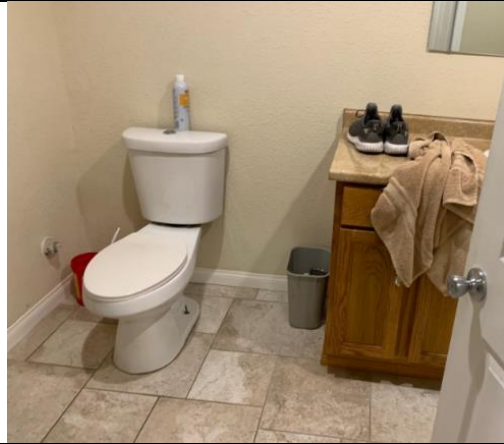
Photo of sample number 22, BDL Quartz Countertop, Within Bathroom

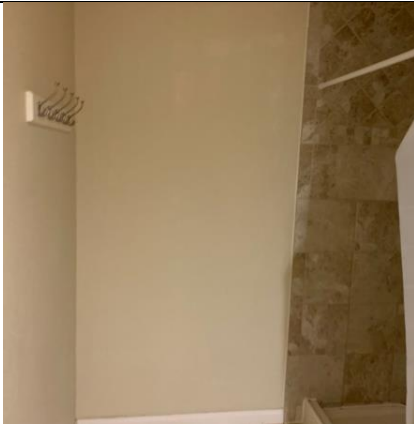
Photo of sample number 25, Non-LBP Ceramic Shower Wall, Within Bathroom

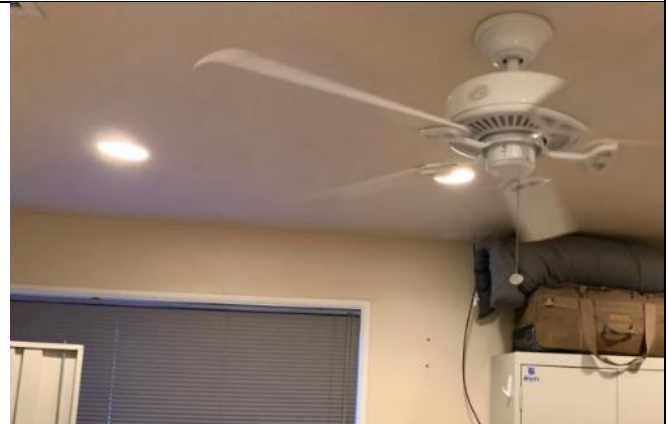
Photo of sample number 28, Non-LBP Drywall Ceiling, Within Bedroom

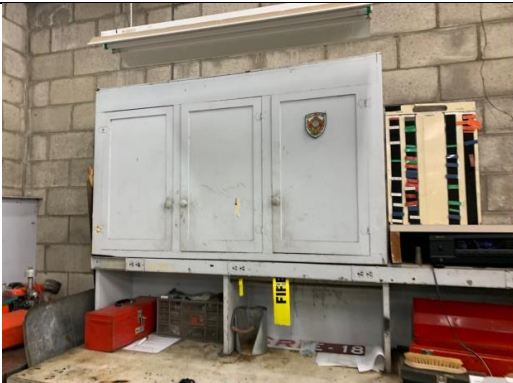
Photo of XRF sample number 4 and Paint Chip sample number 01, LBP Wood Cabinet, Within Station Garage

- In accordance with 29 CFR 1926.62 and 8 CCR 1532.1, any disturbance of LCM and/or LBP should be performed by lead hazard communication trained workers using lead safe work practices that do not result in exposures above the Action Level (AL) of 30 micrograms per cubic meter of air ($\mu\text{g}/\text{m}^3$) and/or Permissible Exposure Limit (PEL) of 50 $\mu\text{g}/\text{m}^3$.

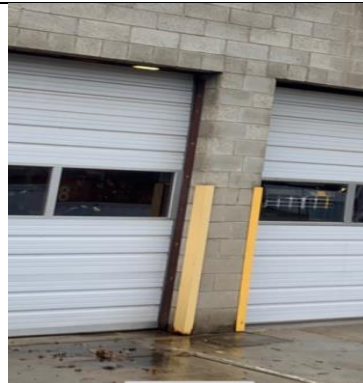
Photo of XRF sample number 11 and Paint Chip sample number 02, LBP Metal Corner Strip, Within Station Garage

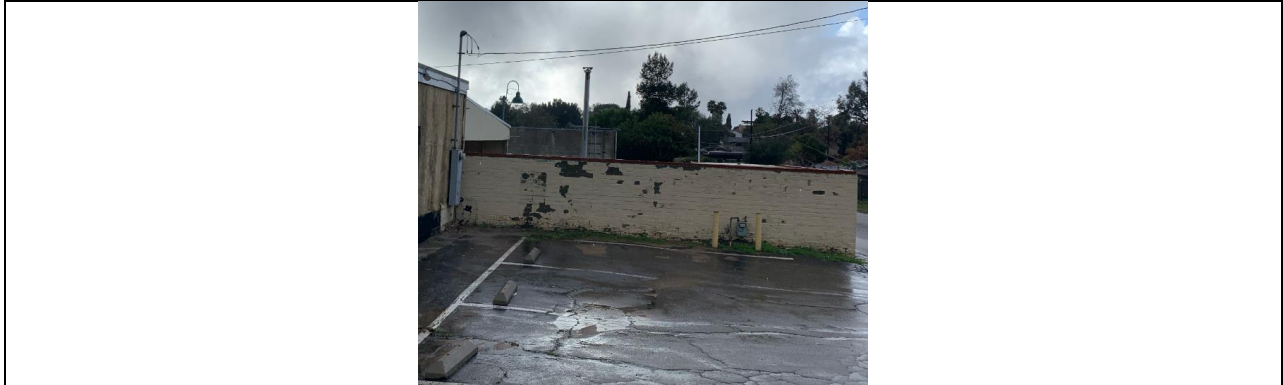
Photo of Paint Chip sample number 03, LCM White Brick Wall Exterior Station 18
